## **APPENDIX C PHOTO LOG**

## Photo Log

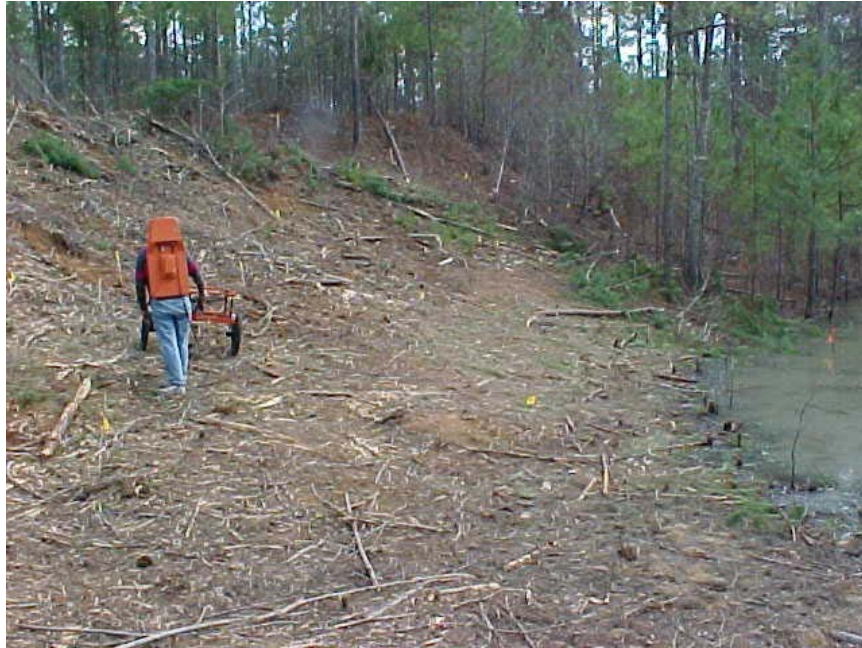
**Photo 1. Reacquisition at Lima Pond using EM61 Time Domain Metal Detector, 3/7/02**

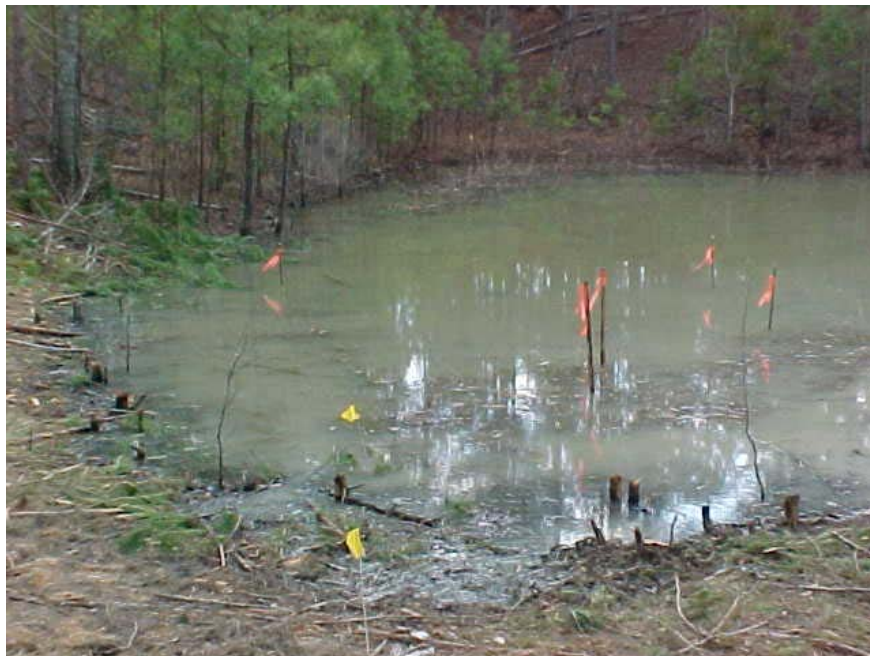
**Photo 2. Lima Pond investigation area, 3/7/02**

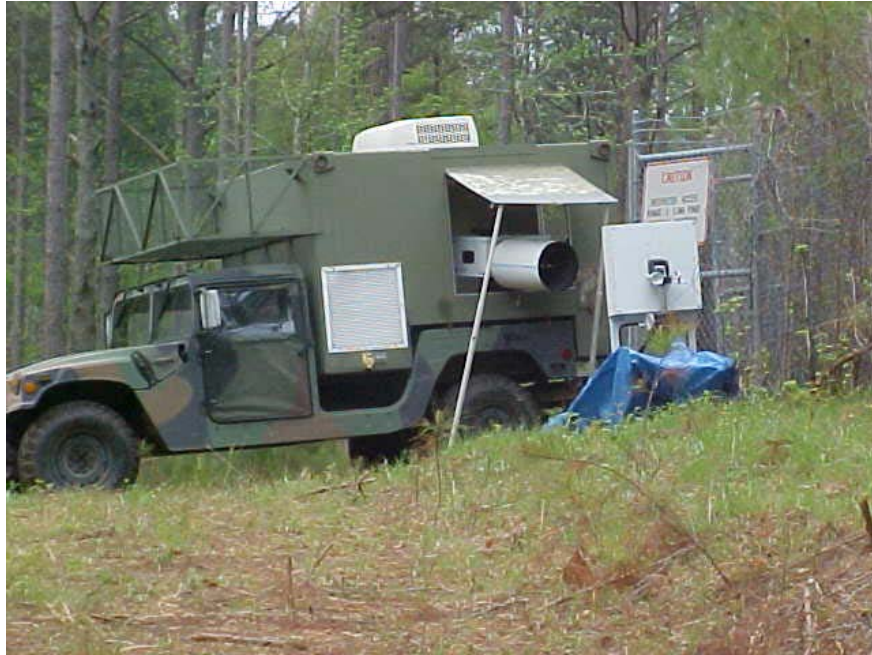
**Photo 3. Open path Fourier Transform Infrared Spectrometry Air Monitoring (OPFTIR) in calibration mode at Lima Pond, 4/16/02**

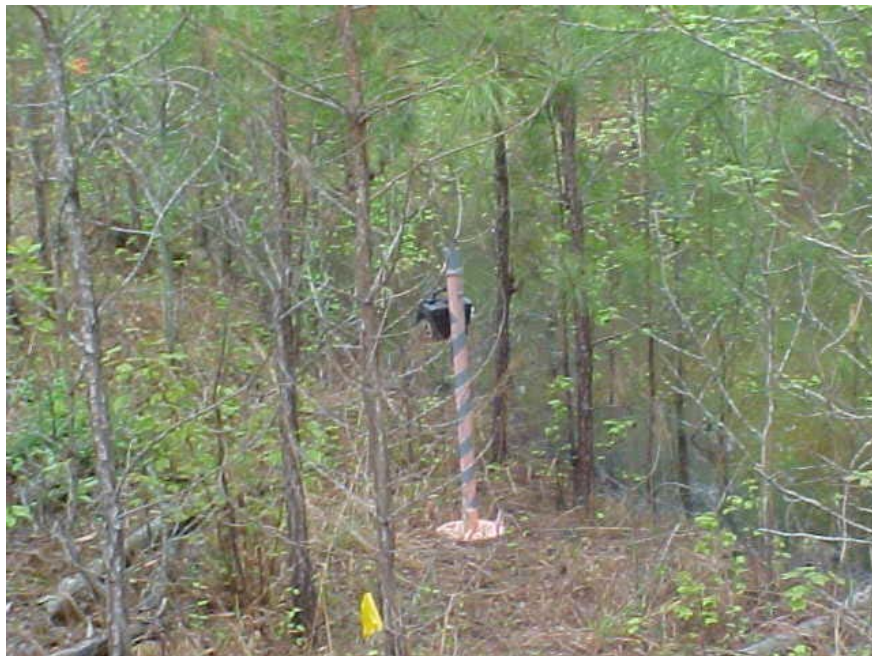
**Photo 4. Perimeter Depot Area Air Monitoring System (DAAMS) station at Lima Pond, 4/16/02**

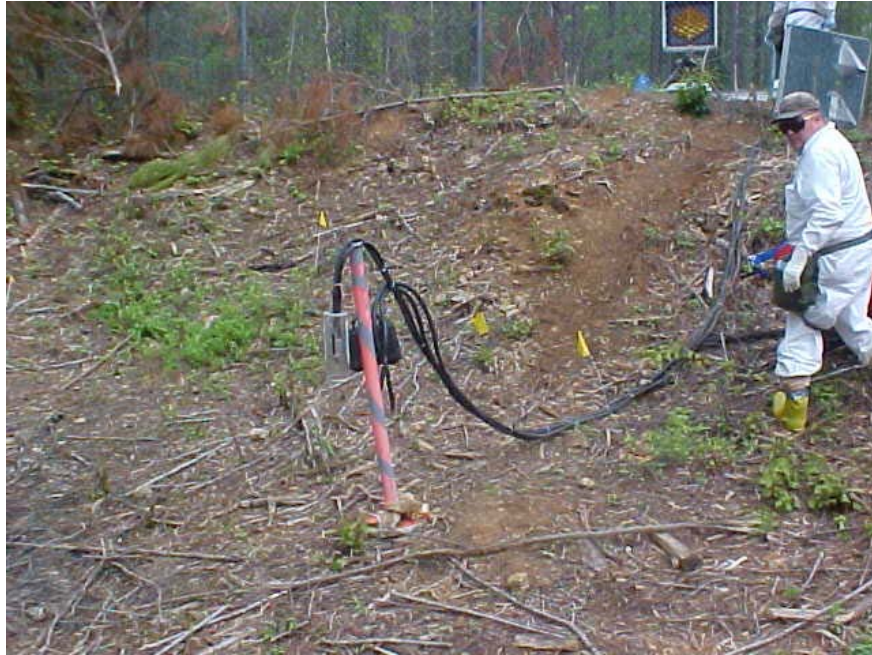
**Photo 5. Miniature Chemical Agent Monitoring System (MINICAMS) sample lines and DAAMS station at Lima Pond, 4/16/02**

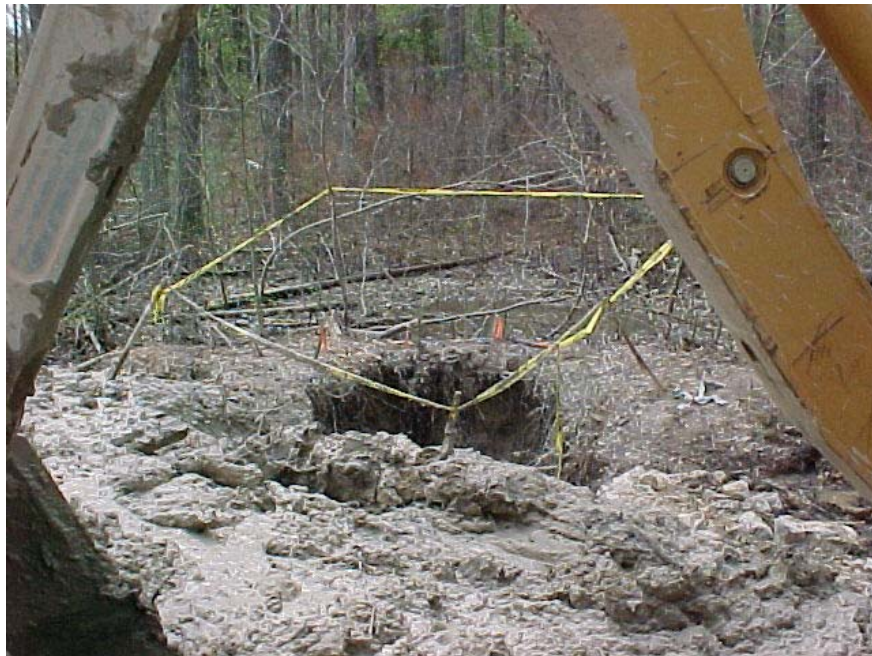
**Photo 6. Anomaly #1 excavation at Old Water Hole, 4/4/02**

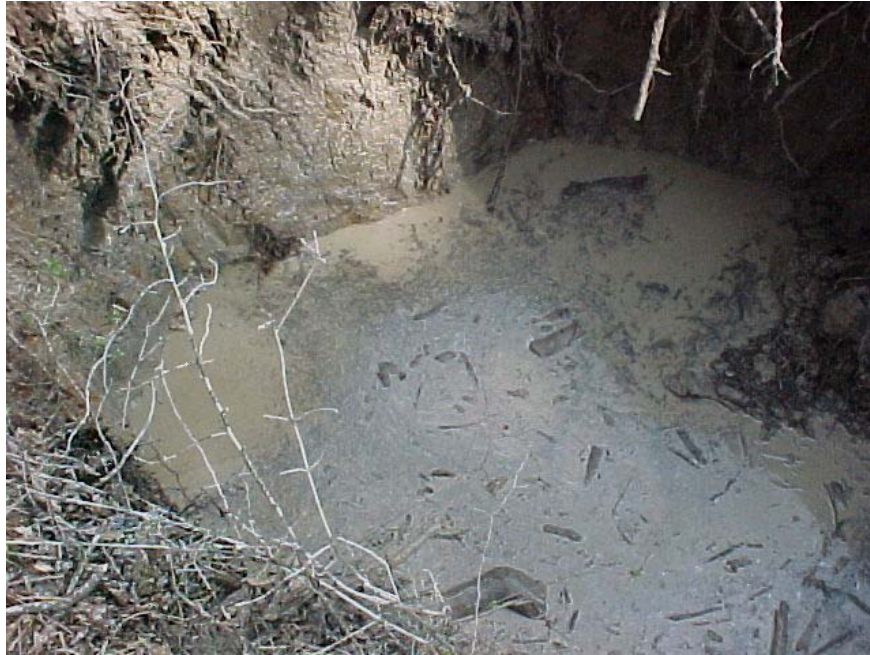
**Photo 7. Anomaly #1 excavation at Old Water Hole, 4/3/02**

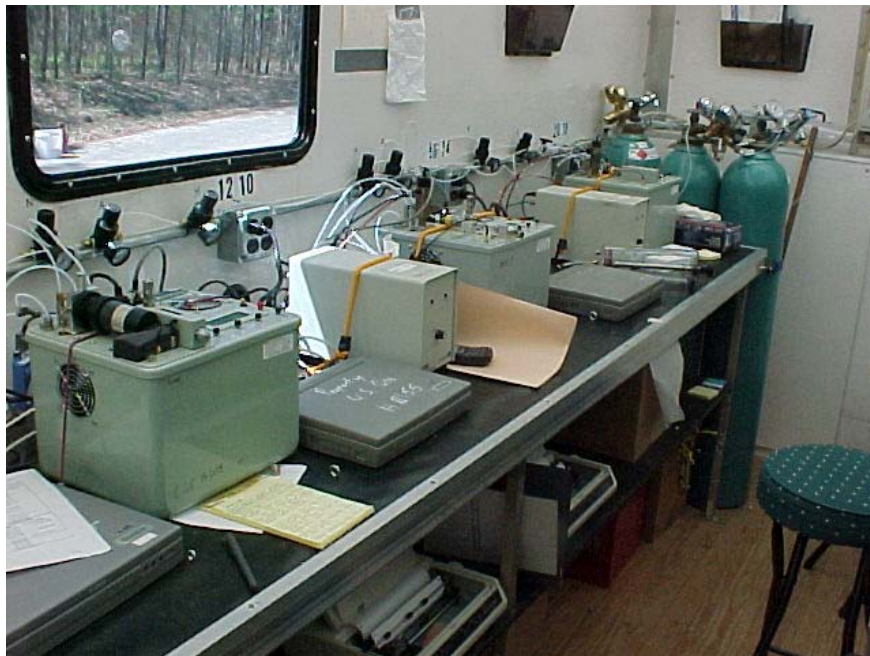
**Photo 8. MINICAMS set-up in Box Truck, 4/2/02**

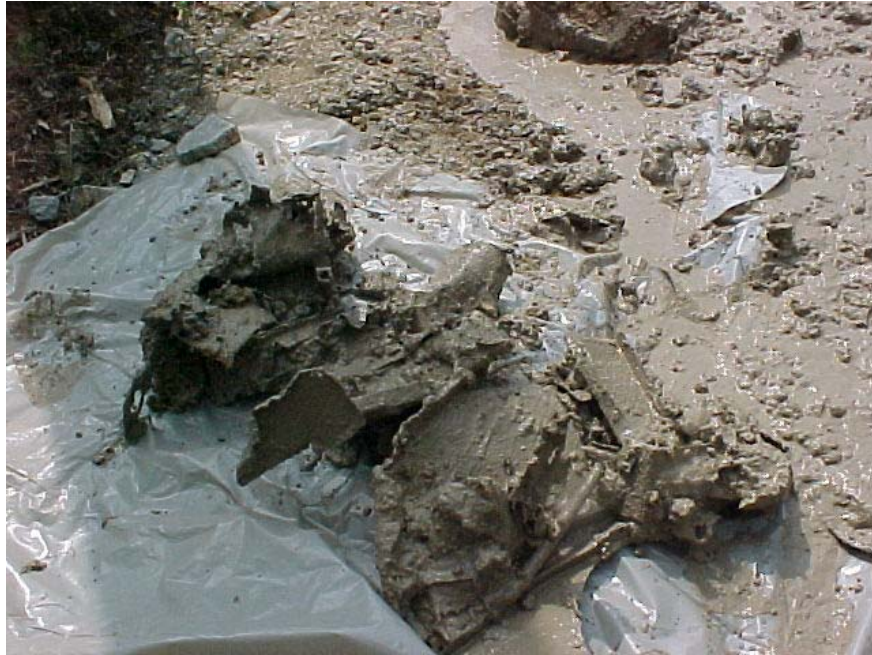
**Photo 9. Scrap metal removed from excavation at Old Water Hole, 4/3/02**

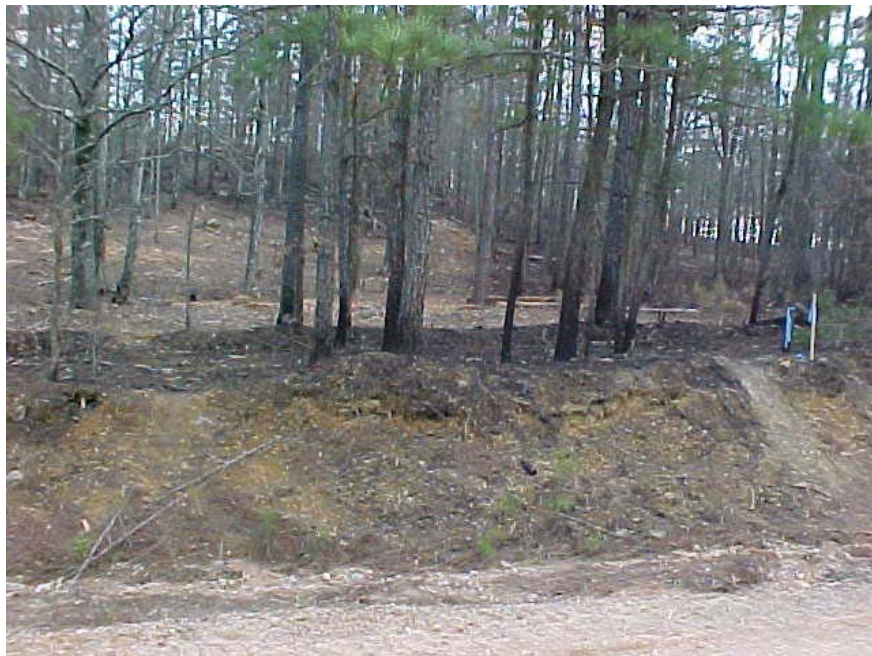
**Photo 10. North end of Former Decon Area, facing south, 3/7/02**

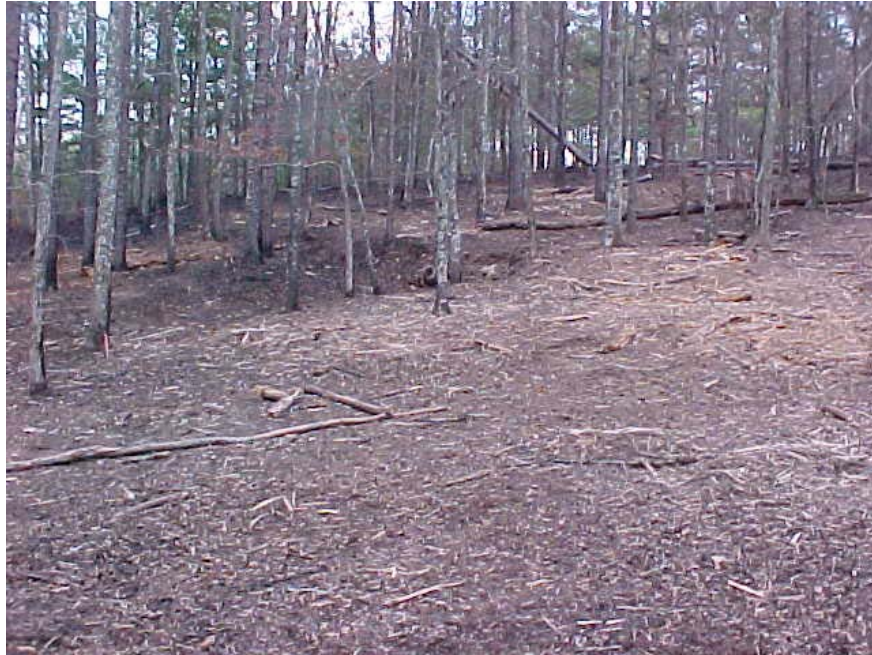
**Photo 11. Middle of Former Decon Area, facing southeast, 3/7/02**

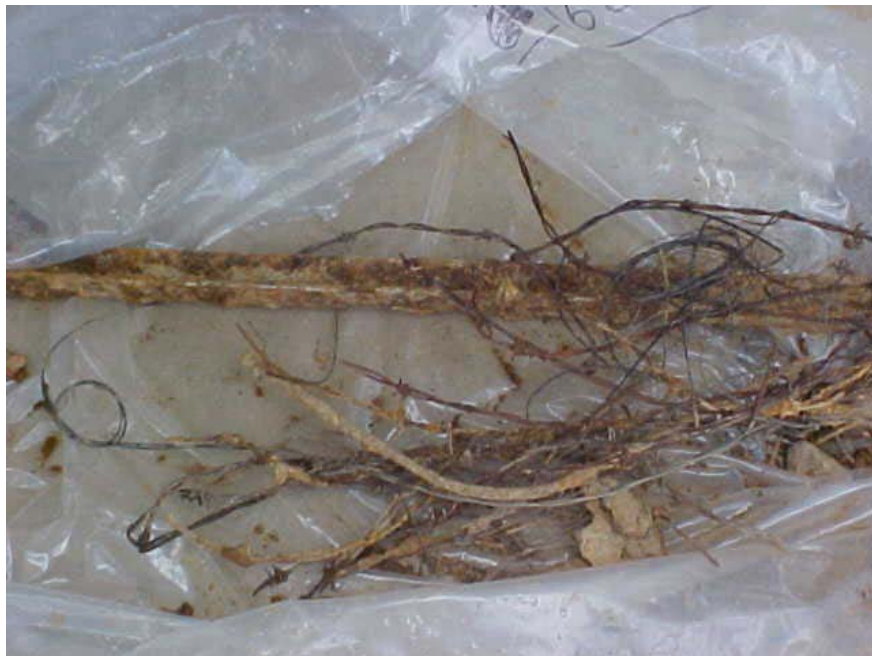
**Photo 12. Scrap metal removed from anomalies investigated at Former Decon Area, 4/17/02**
